CASE STUDY

ACCESS WINDOW WELD INSPECTION

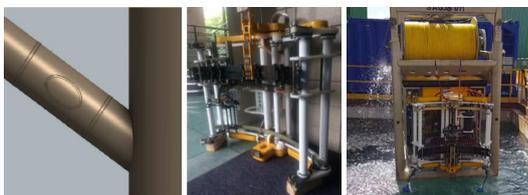
FIGURE 1

Figure 1: Window weld for inspection

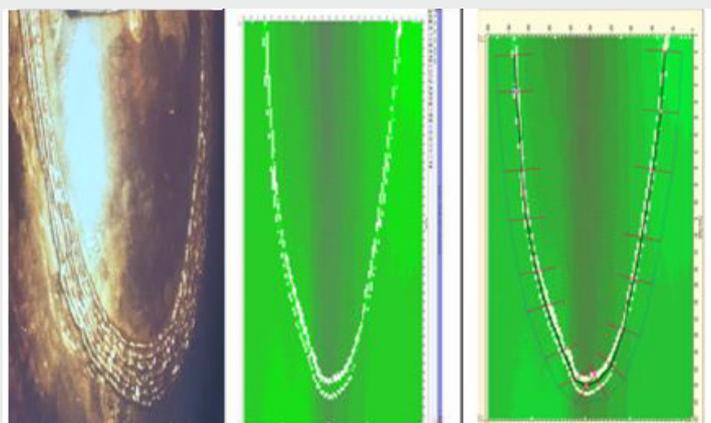
FIGURE 2

Figure 2: 0° map of external weld cap
