CASE STUDY

DEEP WATER ROV INSPECTION ON PIPELINE WITH INTERNAL DEGRADATION

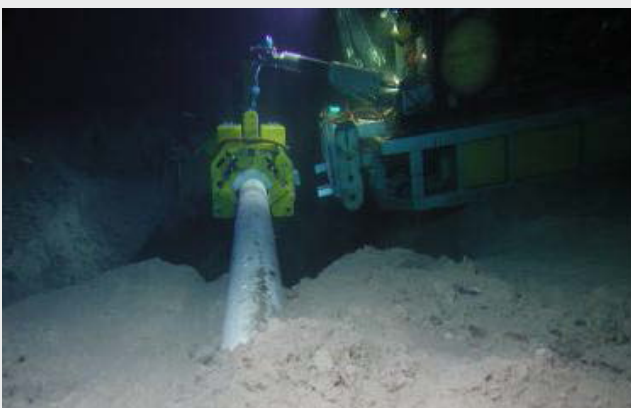
ROV-iT AT 500M DEPTH CONDUCTING TOFD & CORROSION MAPPING:

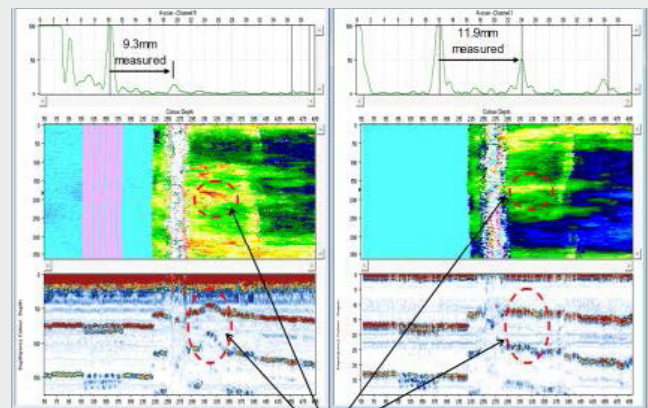
EXAMPLE OF CORROSION MAPPING RESULTS:
