CASE STUDY

ADVANCED SIGNAL PROCESSING

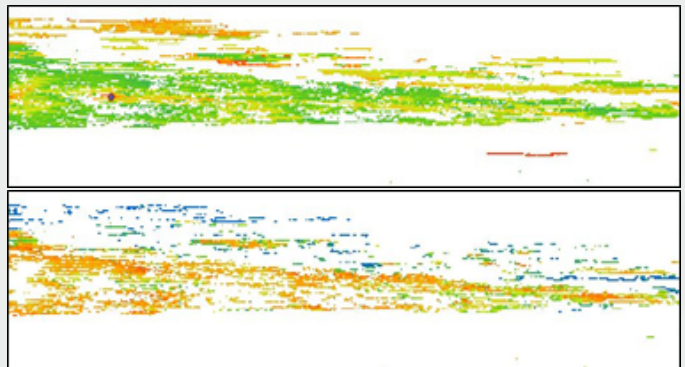
The corrosion mapping results were reprocessed into 'midwall' maps that illustrated responses from laminations and corrosion. These midwall maps were then processed further to only include indications with a backwall response, examples of both of these maps are shown below.

Comparing these maps allowed Sonomatic to determine fully which indications were laminations and which were consistent with corrosion. In addition, we were able to determine that some laminations were close to interacting with corrosion, creating a risk of increased corrosion rates. We were able to highlight these areas to the client to allow them to better plan future inspection campaigns.
