CASE STUDY

WATER PIPEWORK SYSTEM DATA REVIEW AND ANALYSIS

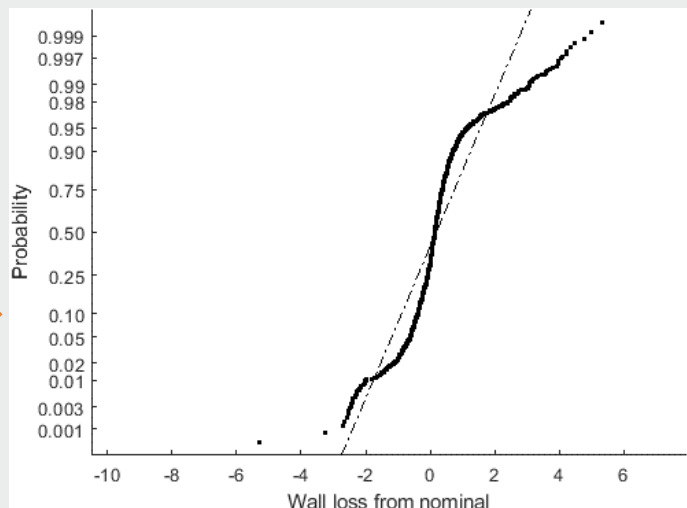
- Numerous spurious readings.
- An incorrect nominal thickness listed against inspection points, giving false confidence in inspection results.
- Regions of replacement that included in corrosion rate calculations, causing the results to be unrepresentatively low.

These issues are illustrated in the plot below, showing large deviations from nominal thickness.

PLOT ILLUSTRATION SHOWING LARGE DEVIATIONS FROM NOMINAL THICKNESS

Sonomatic were able to identify specific areas of concern such as deadlegs, an erosion risk on bends, as well as show evidence of unnecessarily high levels of inspection in areas where no corrosion had been noted. This resulted in the client being able to target inspection in the areas of concern, while reducing the inspection in areas where corrosion was absent. This enabled a targeted, more efficient inspection that made better use of inspection budgets.
