CASE STUDY

ACCESS WINDOW WELD INSPECTION

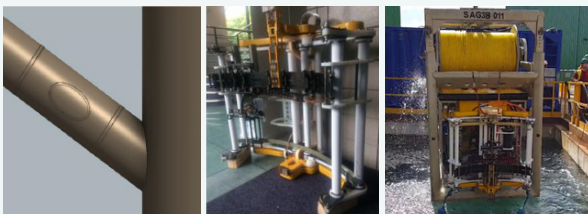
FIGURE 1

Window weld for inspection.
