# CASE STUDY

## DEEP WATER ROV INSPECTION ON PIPELINE WITH INTERNAL DEGRADATION

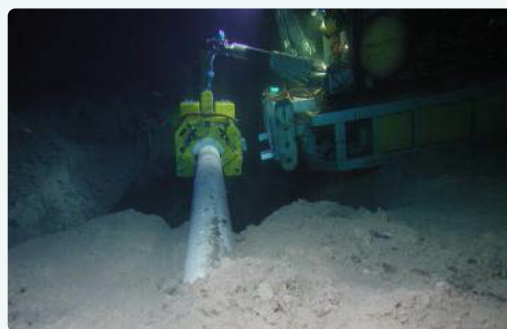
ROV-iT AT 500M DEPTH CONDUCTING TOFD AND CORROSION MAPPING:

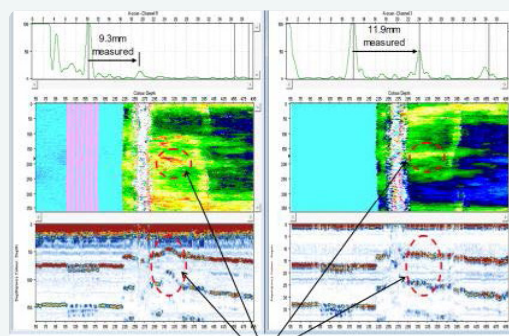
EXAMPLE OF CORROSION MAPPING RESULTS:
