CASE STUDY

DRS™ INSPECTION VALIDATION ON A 30" PIPE WITH COMPOSITE REPAIR

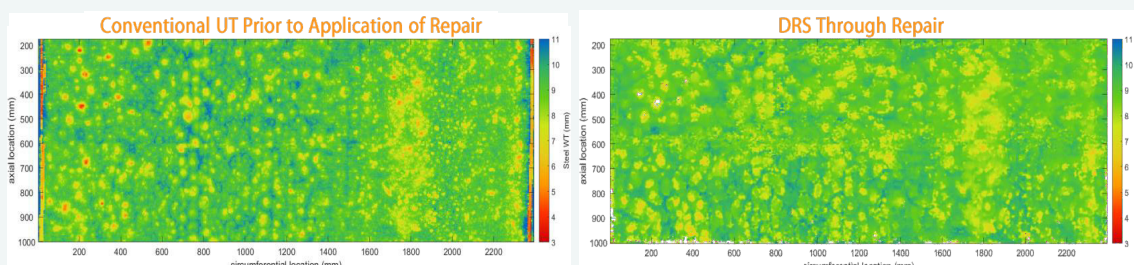
The validation showed that DRS™ is capable of measuring the steel thickness through the composite repair, the DRS™ thickness measurement accuracy is typically $\pm 0.5\text{mm}$, it can detect corrosion pits with diameter down to 10mm and no major flaws were identified in the composite repair.
