CASE STUDY

WATER PIPEWORK SYSTEM DATA REVIEW AND ANALYSIS

SONOMATIC

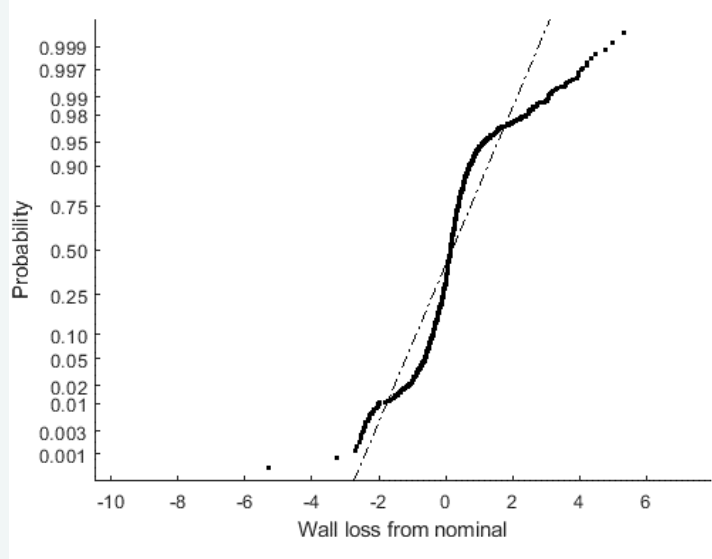
The findings highlighted several issues with the data:

- Numerous spurious readings.
- An incorrect nominal thickness listed against inspection points, giving false confidence in inspection results.
- Regions of replacement that included in corrosion rate calculations, causing the results to be unrepresentatively low.

These issues are illustrated in the plot to the right, showing large deviations from nominal thickness.

Sonomatic were able to identify specific areas of concern such as deadlegs, an erosion risk on bends, as well as show evidence of unnecessarily high levels of inspection in areas where no corrosion had been noted. This resulted in the client being able to target inspection in the areas of concern, while reducing the inspection in areas where corrosion was absent. This enabled a targeted, more efficient inspection that made better use of inspection budgets.
