Case Study

Project: Fitness For Service (FFS) on a 16" Main Oil Line

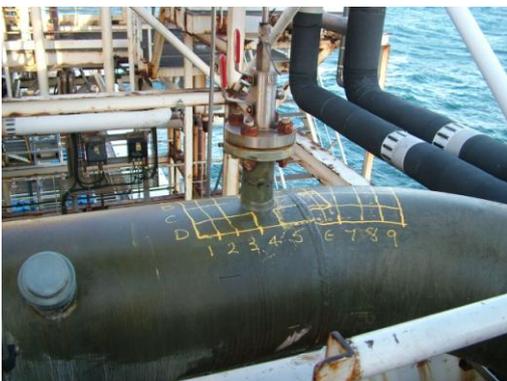
Figure 1:

Problem: Failure of an additive injection quill had resulted in accelerated corrosion downstream of the injection point on a 16" Main Oil Line. Sonomatic were retained in order to ascertain if the line was fit for continued operation in the degraded condition.

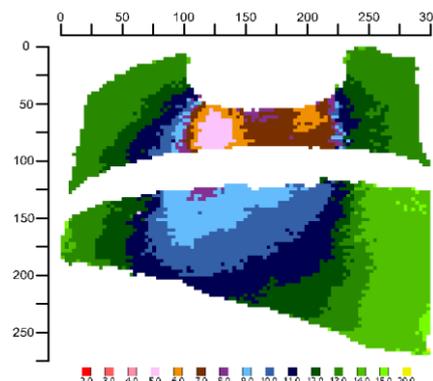
Figure 2:

Corrosion mapping was conducted on the affected region in order to establish the extent of the defect (Figure 2). Time of flight diffraction (TOFD) was then carried out on the welds in order to establish that preferential weld erosion was not evident (Figure 3) and to confirm the minimum thickness.

The measurements were then used in conjunction with operating and design parameters to conduct a fitness for service according to API 579.
