# CASE STUDY

## CIVA MODELLING OF THE INSPECTION OF A NOZZLE TO DOMED END WELD ON A PRODUCTION SEPARATOR

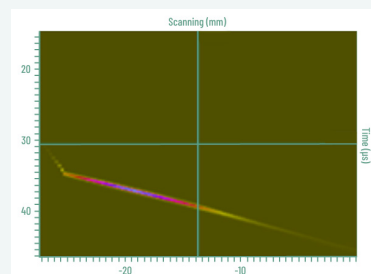
FIGURE 2:

Flaws were placed at several locations within the nozzle weld and results were simulated using a selection of shear wave angled probes (Figure 2 shows the results from a single scan).

Analysis of the results determined the likelihood of detection for each of the flaws within the weld and was used to validate the inspection techniques applied to the nozzle. The use of modelling allowed the techniques to be developed rapidly with confidence in capability provided before deployment offshore. This allowed a rapid deployment of the inspection with confidence in capability. Downtime before the separator was returned to service was thereby significantly reduced and the operator benefited through minimisation of associated lost production. The Civa modelling, along with the inspection results obtained, formed a key element of the operator's case for continued operation.
