CASE STUDY

CRA FLANGE WELDS

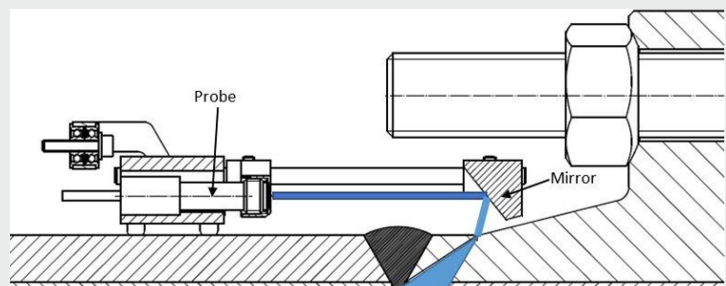
A multiple probe array of selected shear wave angles and TOFD was developed using novel beam emission solutions and fully validated on representative samples. A ROV-iT12 was modified to allow the inspection head to be driven outboard of the main scanner frame and gain access to both sides of the welds without any risk of fouling on the bolts.
