OFFSHORE CONDUCTOR INSPECTION USING INNOSPECTION MEC™ TECHNIQUE

A GCC based client in the Middle East required an inspection of their conductors from under the Christmas tree configuration, down through the splash zone area, and beyond if required.

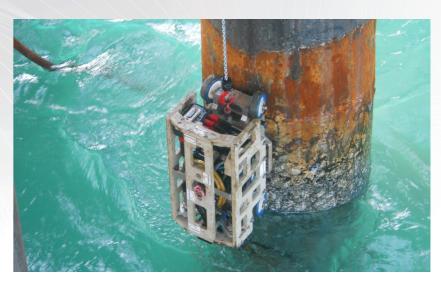
- Fast Reliable Inspection technique, with full coverage.
- Yeroviding a high quality inspection data that can be converted into Matrix format showing the data in high resolution -2mm steps-that can be used for FFS.
- [It can differentiate between internal and external defects.
- Technique is not affected by light marine growth and requires less preparation.
- Topside pitting specially at the splash zone area will not affect the capability of detection for other indications like in other NDT techniques.
- **™** MEC™ Crawlers have additional HD camera for visual inspection.
- **™** MEC[™] Crawlers can be equipped with additional UT sensor array, other techniques and cleaning head if required.

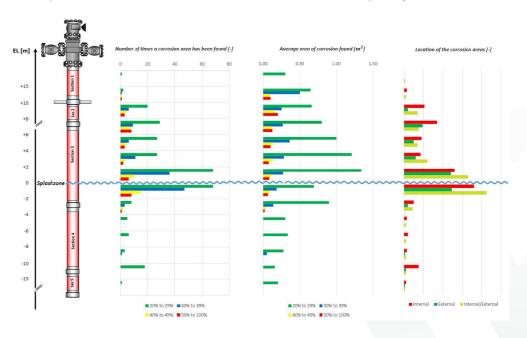
- MEC[™] can provide a fast inspection with full coverage of the conductor from the top (Christmas tree) to sea bed, the inspection of a 30m long conductor can be completed in one shift.
- MEC[™] can provide a separate high resolution report for the external and internal conditions of the Conductor.
- MEC™ data can be transferred into a matrix data report format and be used for FFS which is very important for the client.
- MEC[™] does not require extensive cleaning to collect the data, also can measure external and internal pitting without any issues in the splash zone and other areas.
- MEC™ detections capabilities and sensitivity allows it to detect general corrosion on both sides of the inspection surface and smaller indications like isolated pitting.
