CASE STUDY

PIPELINE INTEGRITY ASSESSMENT

INTRODUCTION

A Fitness For Service (FFS) and detailed analysis on a Subsea export pipeline took place following an inspection via advanced automated ultrasonic inspection.

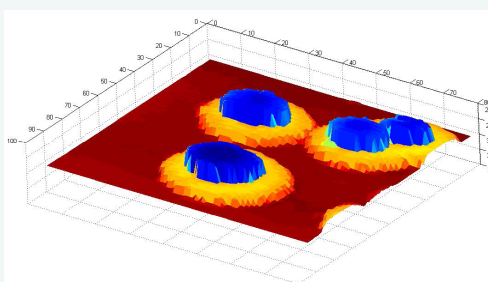
FIGURE 3:

Degradation at an interface between carbon steel and internally clad areas was identified with the potential for additional area to become exposed to the process fluid over time. Statistical analysis was carried out to quantify degradation rates at this area and confirmed that activity had been minimal. Analysis also highlighted new indications within the cladding that had not been strongly evident in earlier inspections.
