CASE STUDY

CORROSION MAPPING ON CAISSONS TO DETECT AND QUANTIFY WALL THINNING

SONOMATIC

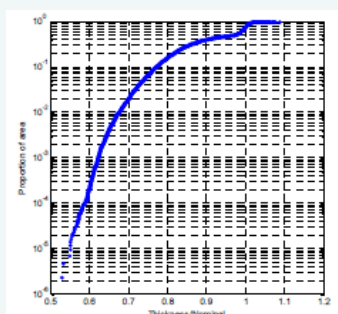
Sonomatic's MAG-Rover was used to collect corrosion mapping data at selected locations (Figure 1) with a width of 700 mm around the full circumference of the caisson. The corrosion mapping results (Figures 2 & 3) accurately define the condition of the caisson.

FIGURE 3: WALL THICKNESS DISTRIBUTION

The detailed information provided by the inspection allows sound integrity decisions to be made with knowledge of the actual condition of the caisson. As the full scan information is stored electronically, repeat inspections allow accurate estimation of corrosion growth rates.
