SUCCESS STORY

MAPPING FPSO CRUDE OIL/WATER BOUNDARIES

MAPPING CONDITIONS OF FPSO CRUDE OIL/WATER BALLAST SHARED BOUNDARIES

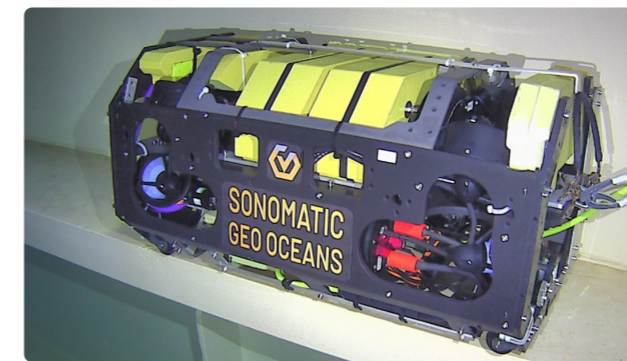
- 📍 The limited time available for final tool development and testing prior to implementation.
- 📍 Limited accurate information regarding the structural layout of the water ballast tank.
- 📍 Orientation of the boundary walls to be scanned, which required different bracketing for each orientation – horizontal, vertical and the hopper at 50°.
- 📍 Sizing of the hatch ways between stringers and some frames, and the presence of handrails and other obstructions around the opening.
