# CASE STUDY

## SUBSEA CORROSION MAPPING OF MARINE BRIDGE PILES

Sonomatic Australia completed an underwater corrosion mapping campaign on a series of marine steel bridge piles to assess structural condition and identify areas of wall loss. The inspection covered multiple pile locations using automated ultrasonic corrosion mapping technology.

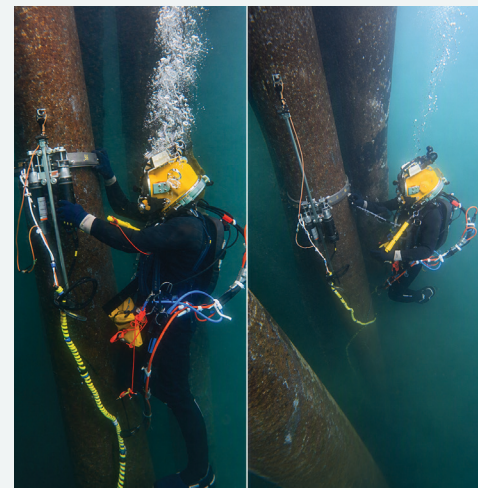
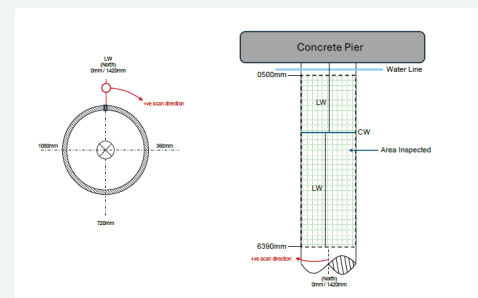
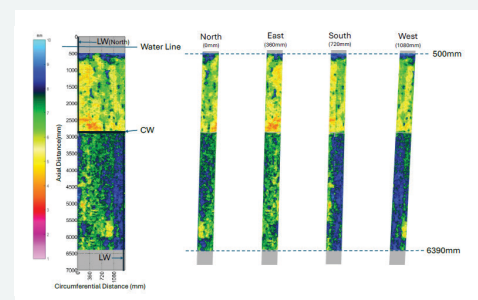
Automated ultrasonic corrosion mapping was deployed to collect high-resolution wall thickness data and generate detailed 2D and 3D corrosion maps of the inspected areas.

- Corrosion-related wall loss was identified and quantified across all inspected locations.
- Detailed condition data provided a clear understanding of pile integrity.
- Inspection results supported informed maintenance and asset management decisions.
- Advanced NDT technology delivered efficient, high-resolution assessment of critical marine infrastructure.
