CASE STUDY

MERLIN CONNECTORS

A client required an ROV deployed inspections of critical zones on Merlin connectors for possible fatigue cracking.

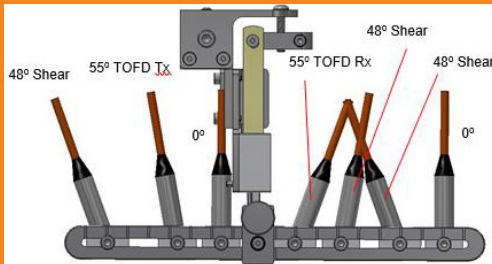
Some of the connectors were within a Base Tank at 140m on the seabed. There was restricted access to gain entry to the Tanks and some of the connectors were in compartments 60m away from the main entrance. A mother ROV would deploy to the entrance, then a deployment ROV would be a small "observation" class LBV vehicle with limited dexterity and thrust/pull capabilities. Limited lighting/no cleaning capabilities. "Dead sub" scenario was a significant risk once the scanner was magnetically adhered to, so a release mechanism needed to be designed. Challenges ultrasonically were to offer a complete inspection suit that covers all the weak locations identified by the fatigue analysis, both internally & externally on the connector.

A multiple probe array of selected shear wave angles and TOFD was developed and validated. A dual-axis magnetic scanner was built (MAG-Nautilus) to ensure neutral buoyancy with a magnetic release mechanism for any dead sub scenario and to allow the LBV to deploy/remove from the connectors.
