SUCCESS STORY

TARGETED INSPECTION OF JACKET
STRUCTURAL CLOSURE WELDS AND
ACCESS WINDOW WELDS

TARGETED INSPECTION OF JACKET STRUCTURAL CLOSURE WELDS AND ACCESS WINDOW WELDS

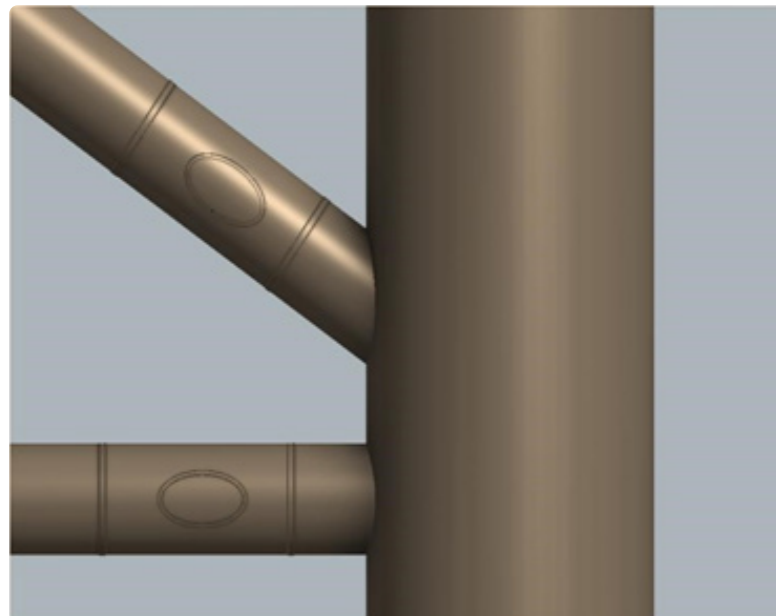
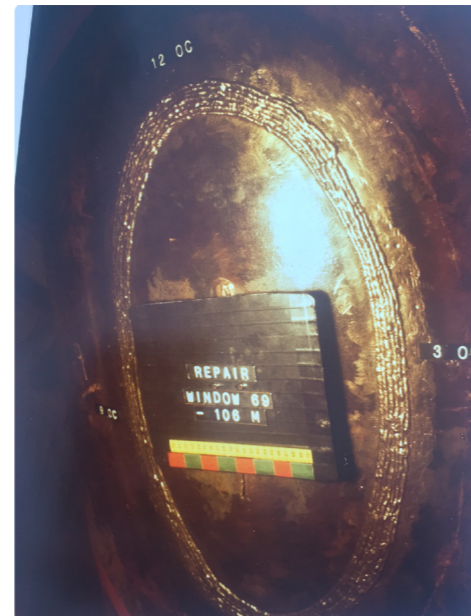
The Access Windows were cut into the jacket to allow internal backfill welding to be conducted during the jacket manufacture. These Access Windows are of differing geometries, so no two welds are the same. Therefore, as part of the structural integrity plan, they require regular inspection for the identifying of cracks emanating from the apex region of each weld.

A client has a relatively low redundancy structure with many fatigue sensitive Access Window and Closure Welds that require monitoring. The platform structure is made up of Closure Welds and Access Window Welds across all four faces of the platform jacket, and there is a yearly requirement for weld inspection on the platform.

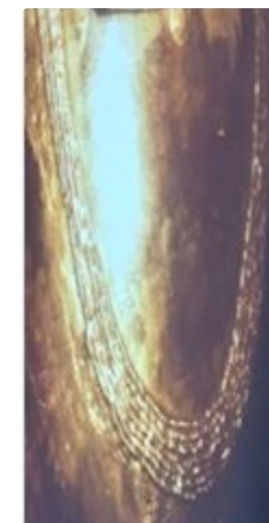
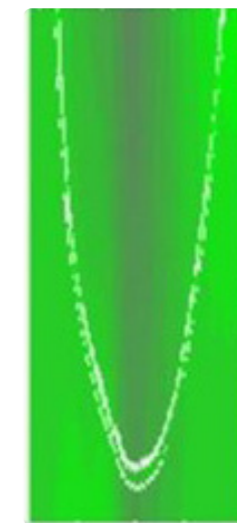
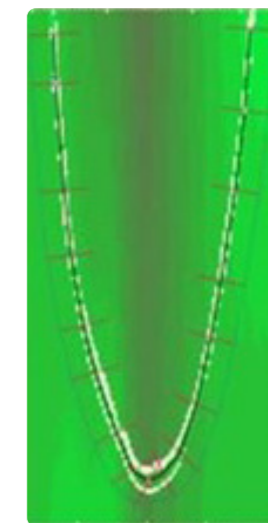
Sonomatic already had the MAG-Rover in service, this was ideal for ROV deployed inspection of Closure Welds. However, the awkward geometries of the AWW's took more consideration. A bespoke tool was designed and developed by Sonomatic with 5 axis of control that can deploy TOFD, 0° and Angle Shear Wave Pulse Echo in one deployment from the platform from a Comanche ROV. The tool has the capability to inspect the apex of each window weld and 250 mm either side of this region.

The inspection process first requires 0° inspection of weld area to map out the geometry. Using sophisticated software, the information collected is then utilised to plot out the weld profile to support the TOFD and Pulse Echo Inspections ensuring the probe assemblies are driven tangentially to the weld centreline around the weld apex.
