# DATA SHEET

STORAGE TANK ANNULAR RING IN-SERVICE INSPECTION

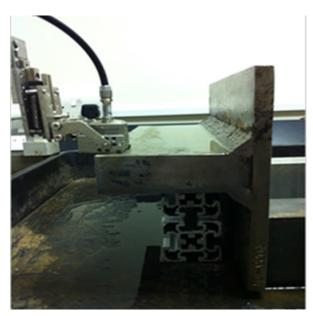
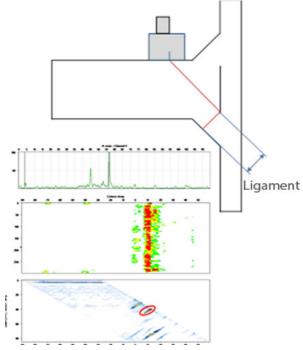
- ✓ Inspection from Tank Wall surface
- Sensitive to internal and external degradation at the critical wall to floor joint region
- **☑** Dual-axis raster scanning for detailed analysis

The internal corner of a storage tank is subject to both corrosion and tensile stresses during its service life, making detection of corrosion and any reduction of a ligament a vital part of any inspection regime.

The stresses on the inner fillet weld, combined with excessive levels of corrosion, would potentially lead to catastrophic failure. Deposits in the product can lead to corrosion of the fillet weld itself and/or the upper surface of the annular plate at the weld toe/HAZ. Moisture from beneath the plate can also cause external corrosion at these locations, and to simultaneously measure the internal fillet weld ligament, or throat dimension.

The technique has been developed in the laboratory and is now ready for site validation. It is envisaged that initial scanning will be performed by rapid, single-axis screening with real-time imaging using a fixed stand-off probe. This will be followed by dual-axis scanning of suspect areas to more reliably image the internal cross-sectional profile. Further investigation may be required by for example, local excavation of the material beneath the weld area with coating removal to facilitate visual and high-resolution ultrasonic inspection.

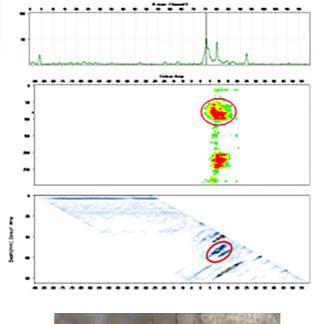
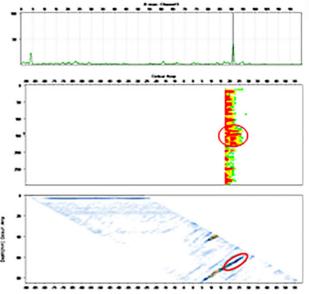
Close Visual Inspection (CVI) is routinely used in order to determine the condition of the internal fillet weld of the wall to annular plate joint. This clearly requires that the tank is taken out of service and extensive, careful cleaning is required. This form of inspection, being dependent on human reliability factors, is not infallible, and areas of damage may be overlooked. There are many tanks for which this is not practical, and in others it is preferable to either have an understanding of the extent of internal degredation ahead of the tank being taken out of service for internal inspection, or to have a supplementary, alternative inspection tool to improve confidence in the reliability of inspection.
