CASE STUDY

DRS INSPECTION VALIDATION ON A 30" PIPE WITH COMPOSITE REPAIR

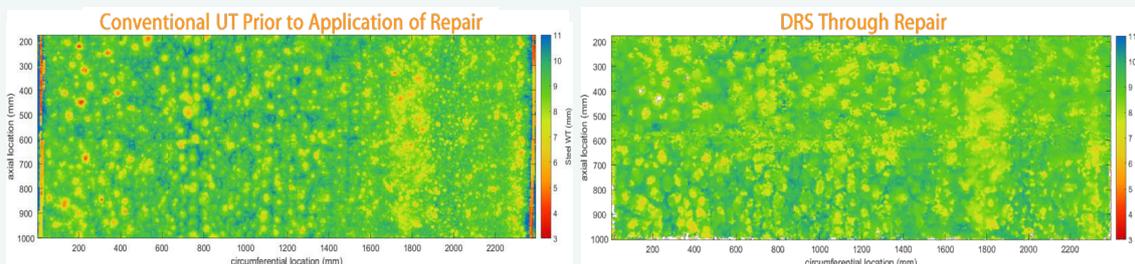
The validation showed that DRS is capable of measuring the steel thickness through the composite repair, the DRS thickness measurement accuracy is typically $\pm 0.5\text{mm}$, it can detect corrosion pits with diameter down to 10mm and no major flaws were identified in the composite repair.

The validation sample was a 30", schedule 40 pipe with extensive internal natural corrosion. The UT and DRS inspections were carried out using Sonomatic's automated Nautilus scanner, a conventional UT transducer and a custom DRS transducer. The scans were collected in 1mm increments axially and 4mm circumferentially. They were then processed to create maps showing the steel thickness.
