DATA SHEET

REPEAT INSPECTION COMPARISON

REPEAT INSPECTION COMPARISONS

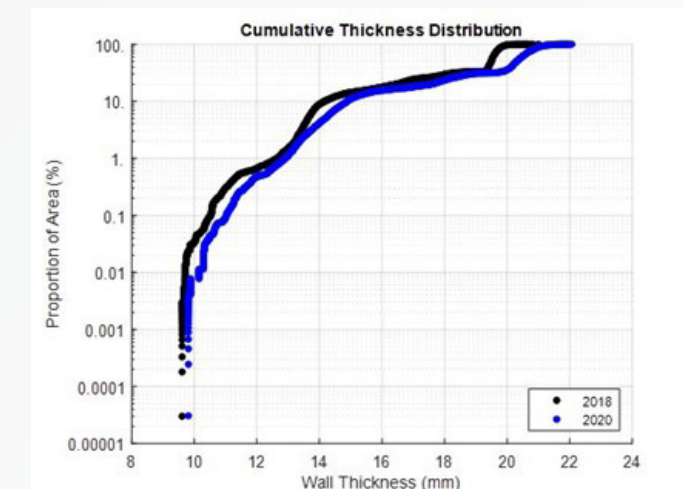
Plotting the thickness data, as shown in Figure 2, shows that there are discrepancies in large parts of the curves and the data does not align well. This was likely the result of systematic differences between the campaigns, largely driven by the large variation in temperature between the inspections. This discrepancy is illustrated best in the upper parts of the curves, which represents uncorroded material. There is a clear offset between the curves on this portion which is representative of a systematic offset between the inspections.

Figure 2: Un-aligned thickness distributions

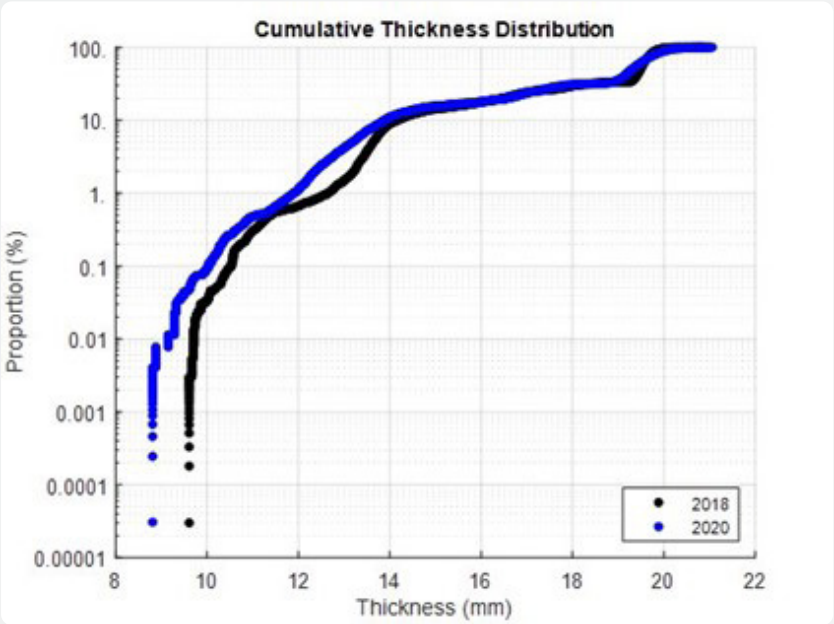
To correct for this and achieve an accurate comparison of minima between inspections, as well as the inspections more generally, the curves are aligned at uncorroded material as shown in Figure 3. Until approximately 14.0 mm, the curves now align well at thicknesses of 14.0 mm and above, there was no discernible change between the inspections. An offset of 1.0 mm was required to align the curves, meaning that results varied between the inspections by 1.0 mm.

Figure 3: Aligned thickness distributions

Once accounted for, this highlighted two findings:

1. The true change in minimum between the inspections was a 0.6 mm decrease, not a 0.4 mm increase.
2. There is also a change in behaviour in the curves between 12 mm and 13 mm, showing that measured in that thickness range have grown, which could point to early-stage thinning.
