SONOMATIC

DATA SHEET

REPEAT INSPECTION COMPARISONS

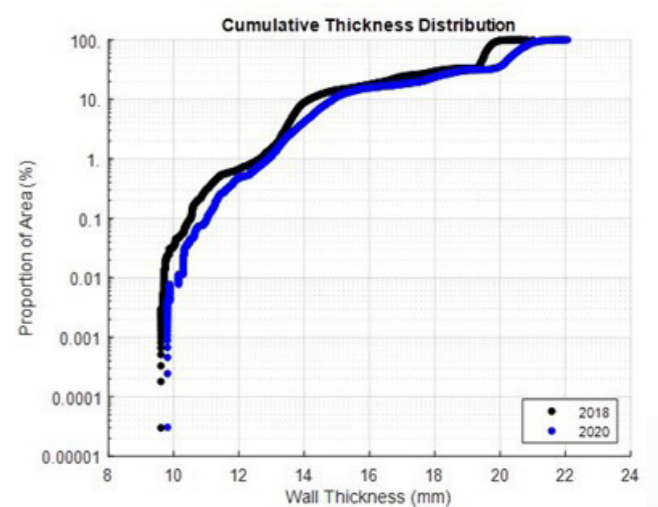
Plotting the thickness data, as shown in Figure 2, shows that there are discrepancies in large parts of the curves and the data does not align well. This was likely the result of systematic differences between the campaigns, largely driven by the large variation in temperature between the inspections. This discrepancy is illustrated best in the upper parts of the curves, which represents uncorroded material. There is a clear offset between the curves on this portion which is representative of a systematic offset between the inspections.

Figure 2: Un-aligned thickness distributions

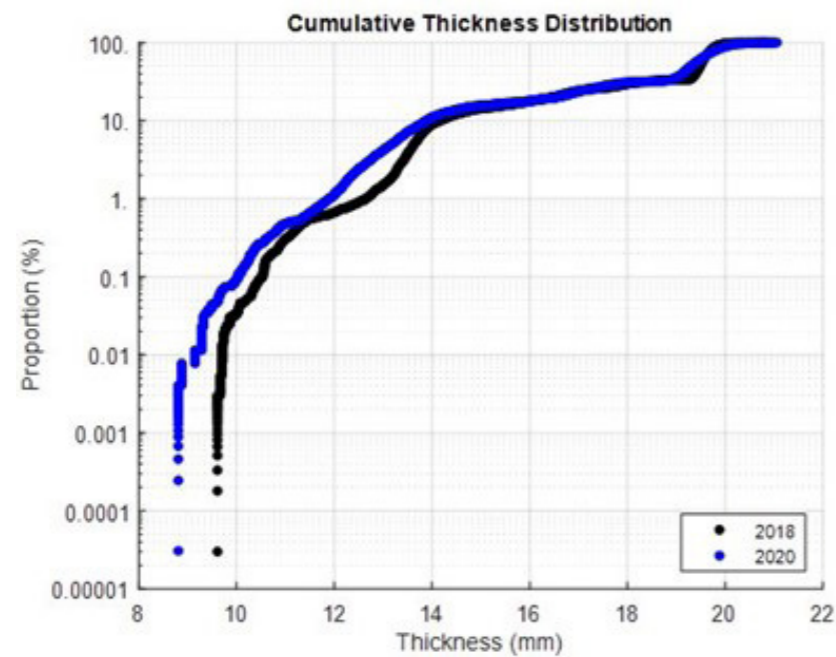
To correct for this and achieve an accurate comparison of minima between inspections, as well as the inspections more generally, the curves are aligned at uncorroded material as shown in Figure 3. Until approximately 14.0 mm, the curves now align well at thicknesses of 14.0 mm and above, there was no discernible change between the inspections. An offset of 1.0 mm was required to align the curves, meaning that results varied between the inspections by 1.0 mm.

Once accounted for, this highlighted two findings:

1. The true change in minimum between the inspections was a 0.6 mm decrease, not a 0.4 mm increase.
2. There is also a change in behaviour in the curves between 12 mm and 13 mm, showing that measured in that thickness range have grown, which could point to early-stage thinning.

Figure 3: Aligned thickness distributions
