DATA SHEET

REPEAT INSPECTION COMPARISONS

REPEAT INSPECTION OF VESSEL DOME

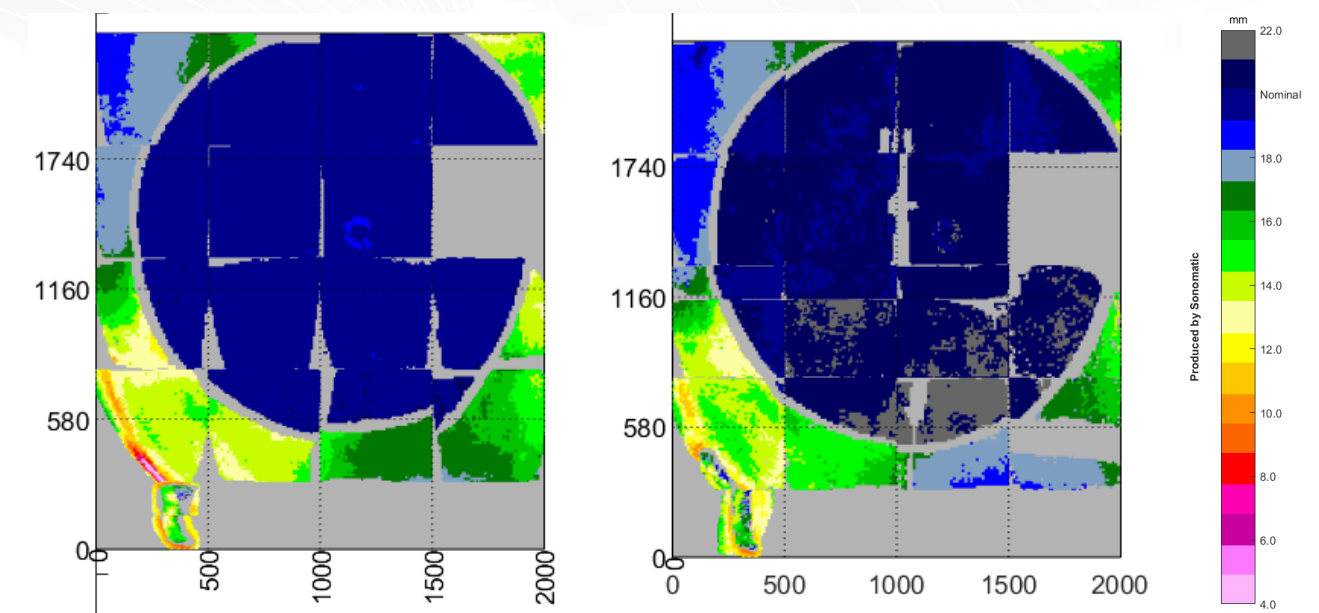
Sonomatic conducted a repeat inspection of a vessel dome. The dome was inspected while the vessel was offline and at ambient temperature in 2018 and again in 2020 while the vessel was online, the operating temperature was 115°C. The inspection results recorded a 0.4 mm increase in minimum thickness between the two inspections. Figure 1, shows the composite thickness maps side-by-side.

Figure 1: Corrosion map 2018 (left) v 2020 (right)

Ultrasound travels through steel at different speeds for different temperatures, in fact at higher temperature the thickness readings would expect to be thinner (faster speed), but the data indicates an increase in thickness, so other factors must be involved.

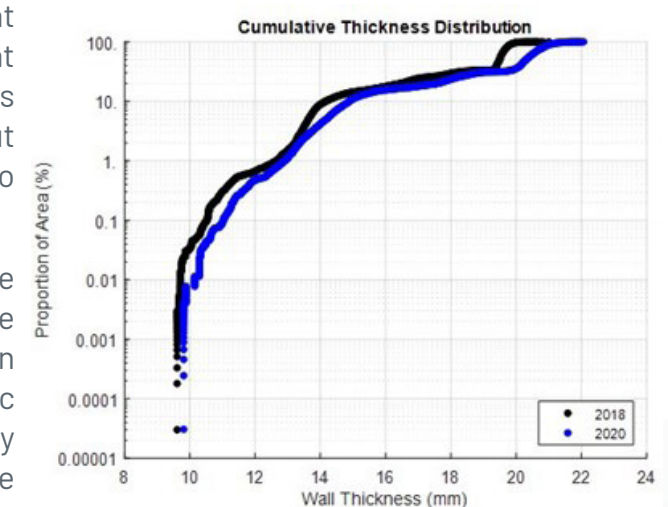
Plotting the thickness data, as shown in Figure 2, shows that there are discrepancies in large parts of the curves and the data does not align well. This was likely the result of systematic differences between the campaigns, largely driven by the large variation in temperature between the inspections. This discrepancy is illustrated best in the upper parts of the curves, which represents uncorroded material. There is a clear offset between the curves on this portion which is representative of a systematic offset between the inspections.

Figure 2: Un-aligned thickness distributions

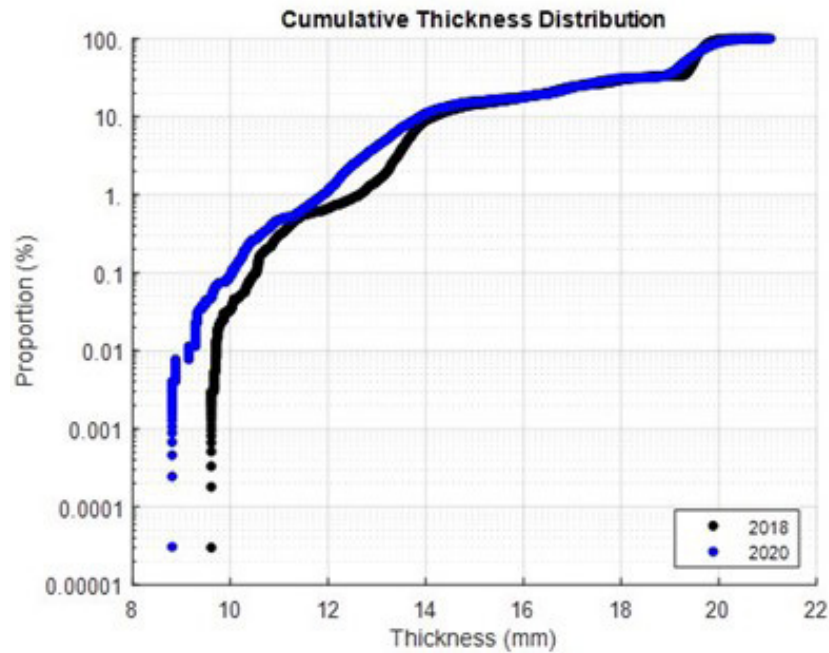
To correct for this and achieve an accurate comparison of minima between inspections, as well as the inspections more generally, the curves are aligned at uncorroded material as shown in Figure 3. Until approximately 14.0 mm, the curves now align well at thicknesses of 14.0 mm and above, there was no discernible change between the inspections. An offset of 1.0 mm was required to align the curves, meaning that results varied between the inspections by 1.0 mm.

1. The true change in minimum between the inspections was a 0.6 mm decrease, not a 0.4 mm increase.
2. There is also a change in behaviour in the curves between 12 mm and 13 mm, showing that measured in that thickness range have grown, which could point to early-stage thinning.

Figure 3: Aligned thickness distributions

Once accounted for, this highlighted two findings:
