SUCCESS STORY

CORROSION MAPPING OF Externally corroded Ast walls

CORROSION MAPPING OF EXTERNALLY CORRODED AST WALLS

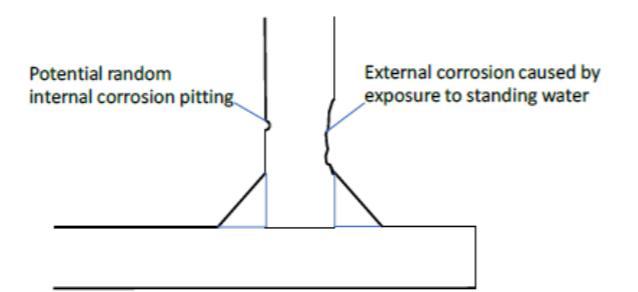
An Atmospheric Storage Tank (AST) had been regularly standing in water at intervals over a number of years. This had led to visible external corrosion. Random internal corrosion pitting had also been noted during previous internal inspections. Concerns had been raised over the possibility of coincident internal and external corrosion causing the corrosion allowance to have been exceeded. The incumbent inspection contractor had arranged to remove all corrosion product from the external surface, but were only able to take thickness readings at isolated locations due to the irregular surface giving contact problems.

Figure 1. Details of the observed external corrosion and potential internal corrosion.

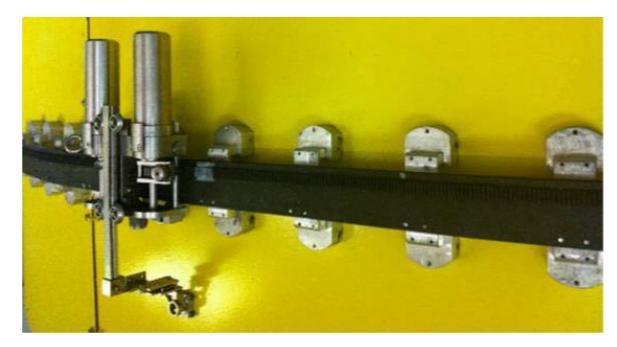
A flexible carbon fibre composite track was attached to the tank wall with magnetic feet. The track ensured conformity in the circumferential direction whilst providing a rigid platform in the vertical plane. The ultrasonic probe was mounted a fixed distance from the external surface and coupling to the surface was achieved using a water column (bubbler). A band of measurements was collected 150 mm above the wall to annular plate attachment weld at locations where corrosion could be seen visually to be most severe.

Figure 2. Nautilus scanning system configured for scanning on a tank wall.

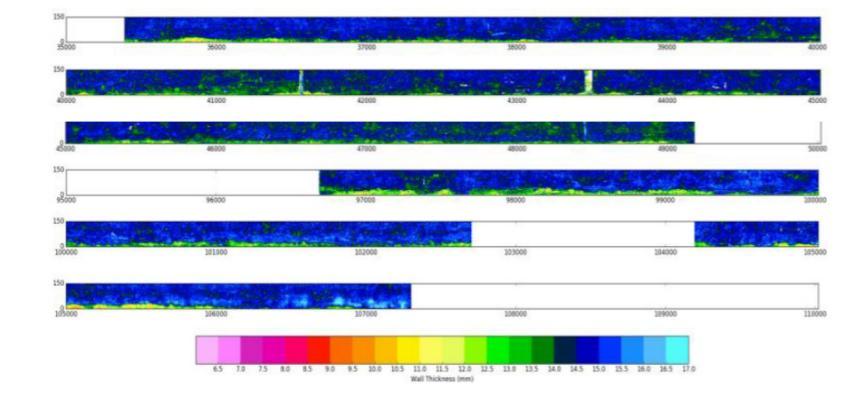
Figure 3. Composite corrosion map over parts of the tank circumference.

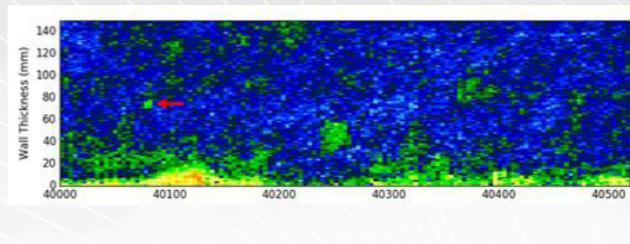
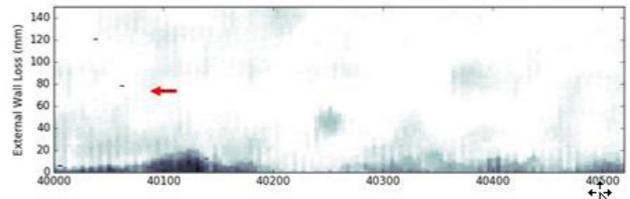
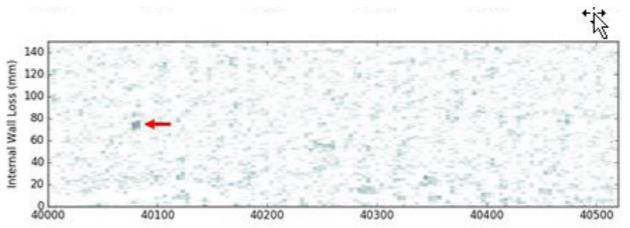
Figure 4. Detail of a corroded area

Wall thickness plat

Internal profile

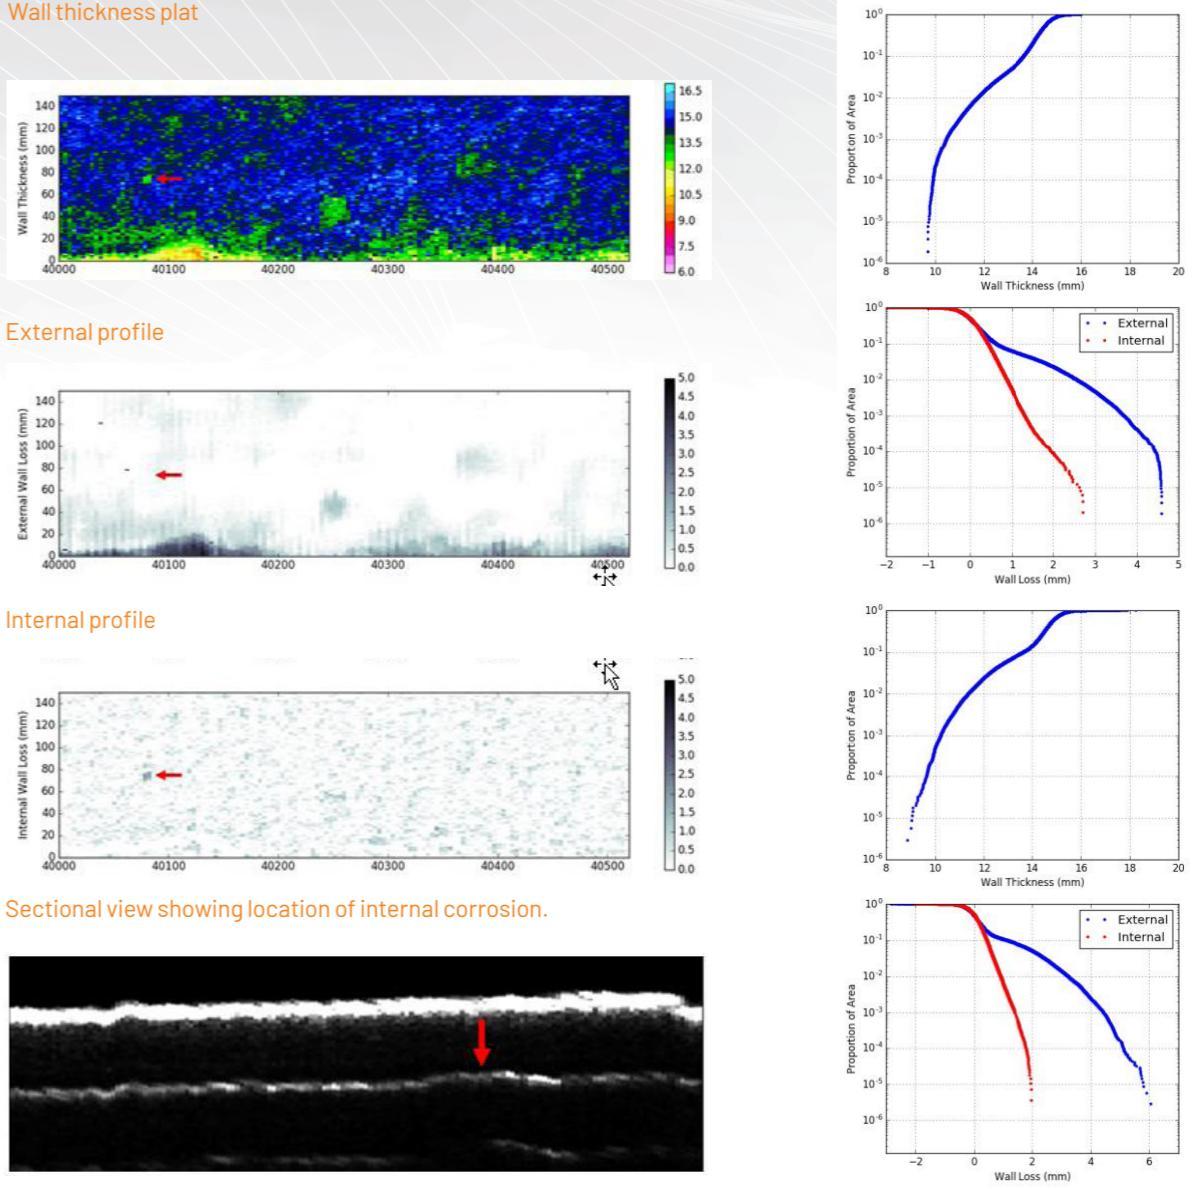
In this example, the internal random pitting was shown not to be coincident with external corrosion. The minimum wall thickness was, therefore, greater than would be the case for overlapping corrosion. The high-quality data was used in a statistical analysis to estimate on a probabilistic basis, the worst case condition. The findings of the inspection and analysis supported a case for continued operation of the tank with no need to remove it from service for repair or replacement. This resulted in substantial business benefits to the client.

Figure 5. Wall thickness distribution plots.

The data obtained also forms a reliable baseline for accurately monitoring future corrosion growth, thereby efficient through-life management of the tank. The data can also be exported directly into a finite element model for fitness-for-service assessment.
