## CASE STUDY

## HIGHLY CURVED SURFACE INSPECTION USING VIDEO TRACKING SOFTWARE

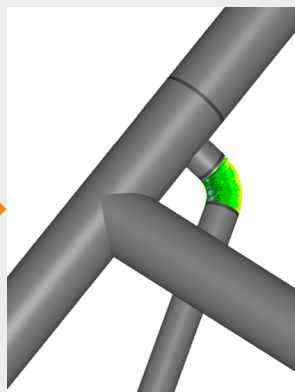
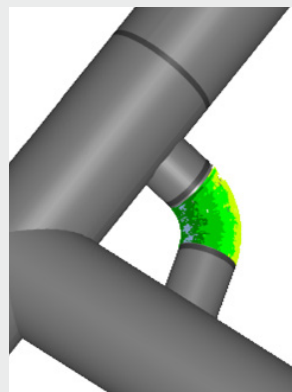
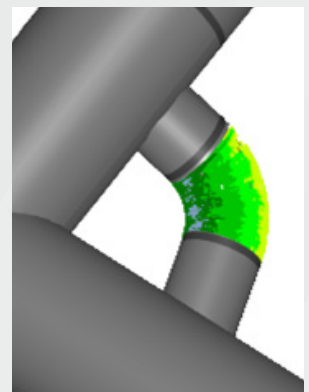
This inspection required Sonomatic to enact a setup which tracked the collection probe at an oblique angle and had to correct for the 3D curvature of the object being inspected. To achieve this the integrity team was tasked with developing custom algorithms to account for:

- The oblique angle.
- The 3D curvature of the surface.
- Allow for double curvature, i.e. bends.

The methodology was trialed, demonstrated, and rolled out successfully on this project. This methodology has since been utilized on other projects with similar challenging requirements.
