# CASE STUDY

## INSPECTION OF BALLAST TANK PLATES AND WELDS USING SIMS

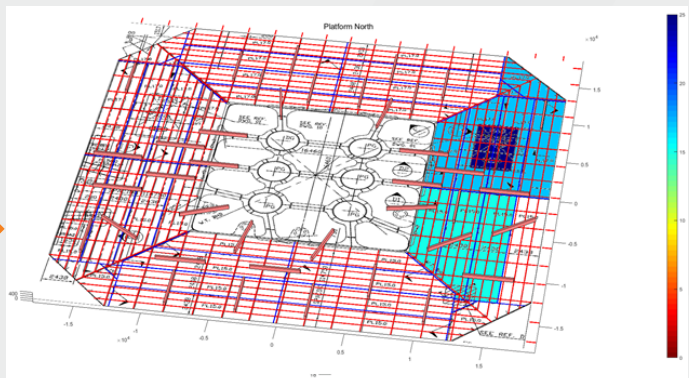
The image shows the model of the tank that was created with the weld layout. Data was uploaded onto the model and could be displayed in different ways, for example the image shows plates coloured by minimum thickness on the plate.
