CASE STUDY

GOOSENECK BEND INSPECTION

A client required an ROV deployed high resolution corrosion mapping inspection for 360° circumferentially, and along the full length, of 8", 10.75" and 12" duplex steel gooseneck bends and elbows at water depths of up to 1400m. This was an urgent request with only a 6 week window to develop a complete solution.

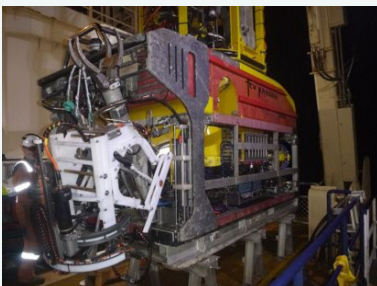
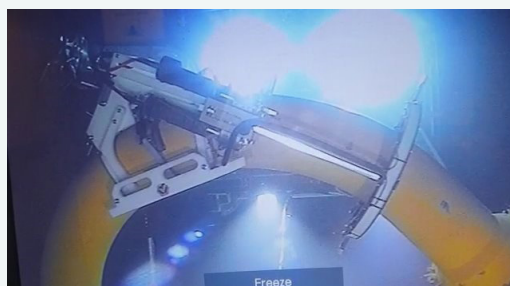
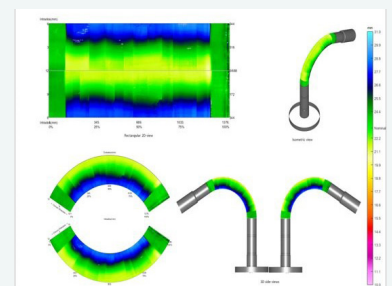
The solution provided accurate circumferential and axial encoded feedback to provide detailed corrosion maps of the full lengths for each bend.

The timescales to deliver a field practical solution were limited. Due to the various diameters and geometries that were to be inspected, any tooling would have to be readily adaptable to accommodate. The solution was to be ROV deployable, robust, provide accurate positional feedback and ultrasonic thickness measurements. To expedite the development, the solution was to design and fabricate a bespoke variable diameter scanning frame to deploy a Sonomatic Nautilus dual axis scanning system with hydraulic clamps and dual inspection heads such that full 360° coverage could be achieved. The data presentation software was enhanced to correct the data for any curvature effects.
