CASE STUDY

GOOSENECK BEND INSPECTION

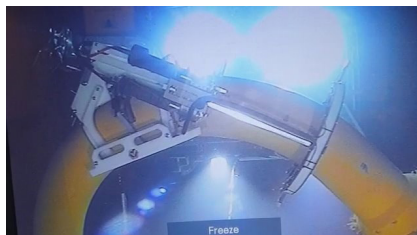
To expedite the development, the solution was to design and fabricate a bespoke variable diameter scanning frame to deploy a Sonomatic Nautilus dual axis scanning system with hydraulic clamps and dual inspection heads such, that full 360° coverage could be achieved. The data presentation software was enhanced to correct the data for any curvature effects.

The solution provided accurate circumferential and axial encoded feedback to provide detailed corrosion maps of the full lengths for each bend.
