CASE STUDY

SUBSEA EXPORT RISER INSPECTION USING DRS

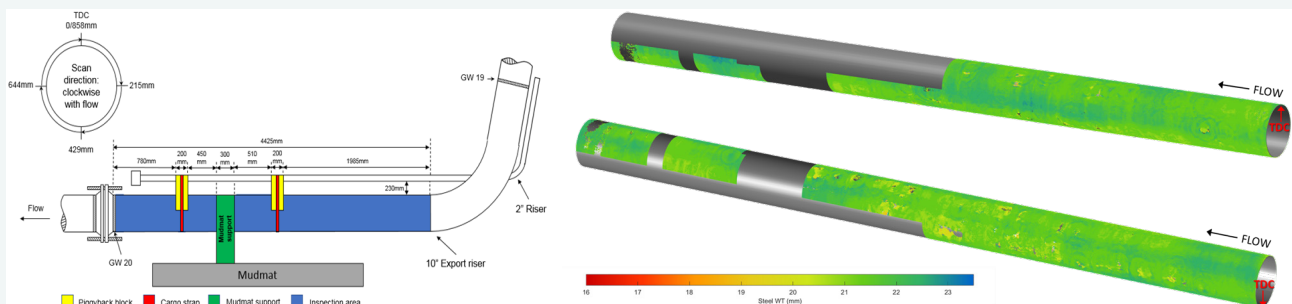
Using the DRS technique, Sonomatic were able to build a thickness map of the area of interest on the subsea riser. The results identified regions of degradation which were below the nominal wall thickness.
